**Flood Control Project Maintenance
Levee Inspections**
LMA District Cover Sheet
Spring 2017 Levee Inspection Results

Yolo County Service Area 6

Spring 2017 Levee Inspection Results

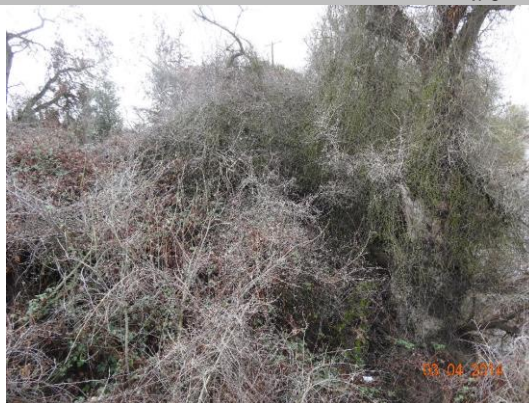
Photo 2 of 3 : UCIP_SP_2017_31904_58227.jpg

View of waterward toe photo taken from bridge.

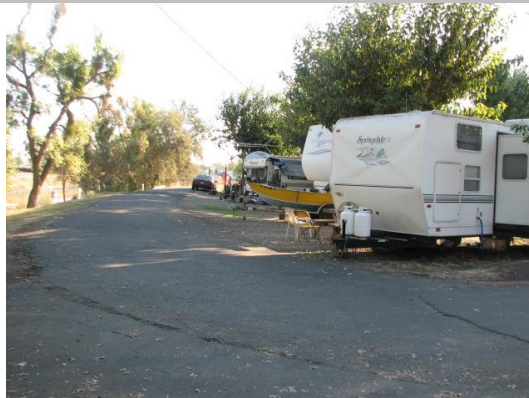
Photo 1 of 2 : SP_2017_NA0022_350_28_20170320_00028.jpg

LM Start	0.22	Rating **	M	Issue No.	28 (cont)
LM End	0.25	Issue Type +	En	Location *	LS

The RV park is encroached into the levee crown. Fall 2013

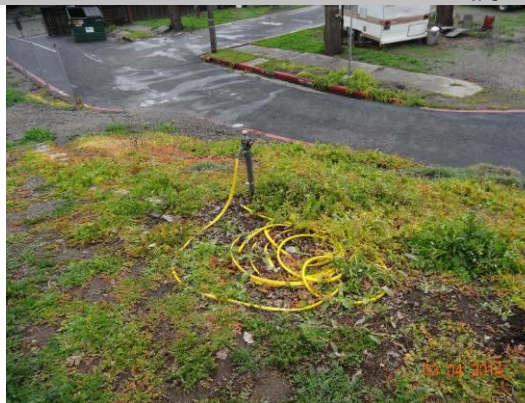
Photo 1 of 3 : UCIP_SP_2017_45403_60805.jpg

Comment Code					
Inspector Comment					
FS_ID:45403 DS_ID:19513 EP_NO: 9424 Repair Type: Non-Urgent Crossing Status: Indicator Found UCIP Comments: Unable to determine alignment of crossing--it's either through levee or along landward side. It appears that the waterline goes along landward side. Need to contact owner to obtain additional information about crossing. 2 inch metal pipe sticking out at the waterward berm edge. FIELD_STRUCT_DESC: Water pipe through the levee at an unknown depth below the crown. Faucets in the landside (LS) slope. (Automatic Board Order (ABO) issued as Permit No. 9424, 1974 - Ivey). [Additional Reference(s): DWR Levee Log, 1990 and 2005]. FS Date: 3/4/2014

Spigot located on landward side.

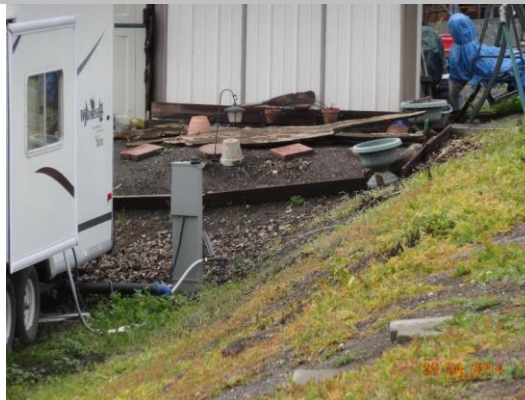
Photo 2 of 3 : UCIP_SP_2017_45403_60804.jpg

Spigot located on landward toe.

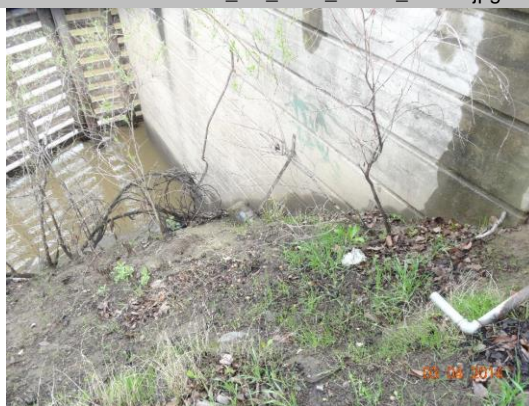
Photo 1 of 2 : UCIP_SP_2017_31906_58238.jpg

FS_ID:31906
DS_ID:19534
EP_NO: 17016
Repair Type: Non-Urgent
Crossing Status: Indicator Found
UCIP Comments: Unable to confirm crossing alignment--steel pipe visible on waterward side however, unable to confirm if crossing is the same one found during field confirmation. Need to contact owner to verify alignment and status of crossing. Slope was too steep to verify and obtain additional information about pipe.
FIELD_STRUCT_DESC: Three 2-inch and three 1.5-inch fiber optic conduits through the levee, encased in a single high-density polyethylene (HDPE) conduit, 30-feet below the levee crown. Concrete caps on both ends of the casing, on the landside (LS) and waterside (WS). Voids in the HDPE conduit grouted. (Permit No. 17016, 2000 - Pacific Fiber Link, LLC).
FS Date: 3/4/2014

Steel pipe located on waterward side--pipe disconnected.

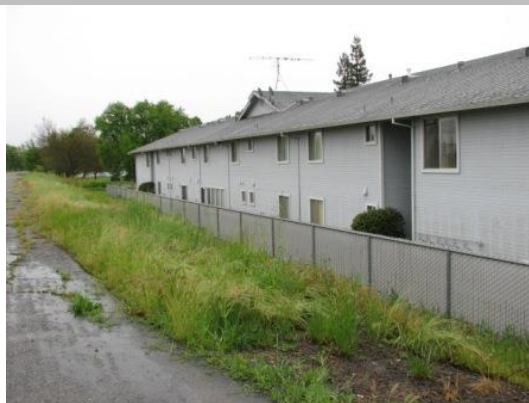
Photo 1 of 1 : SP_2017_NA0022_350_26_20170320_00025.jpg

LM Start	0.35	Rating **	M	Issue No.	26
LM End	0.39	Issue Type +	En	Location *	LS
Category	Earthen Levee			GPS Latitude/Longitude	
				Start	End
Item	Encroachments			38.801886 °	38.802020 °
				-121.719588 °	-121.718889 °
DWR ID	DWR_NA0022_01_s_2012_26				
Comment Code					
BU : Building					
Inspector Comment					
Apartments with chainlink fence with lathe woven into it.

The apartments and fence along the toe of the levee. Fall 2013

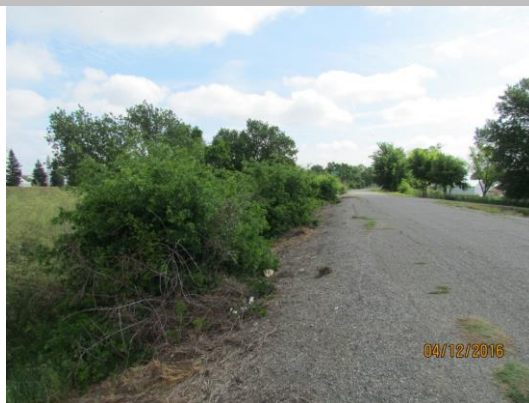
Photo 1 of 1 : SP_2017_NA0022_350_102_20170320_00083.jpg

View of the trees on the waterward side of the levee looking downstream. Spring 2016.

LM Start	0.35	Rating **	M	Issue No.	102
LM End	0.48	Issue Type +	Ma	Location *	WS
Category	Earthen Levee			GPS Latitude/Longitude	
				Start	End
Item	Vegetation			38.801887 °	38.802225 °
				-121.719587 °	-121.717186 °
DWR ID	DWR_NA0022_01_s_2016_102				
Comment Code					
V2 : Remove the wild growth other than native grasses from the levee slopes.					
Inspector Comment					
Remove oak tree that is less than 4" at breast height.

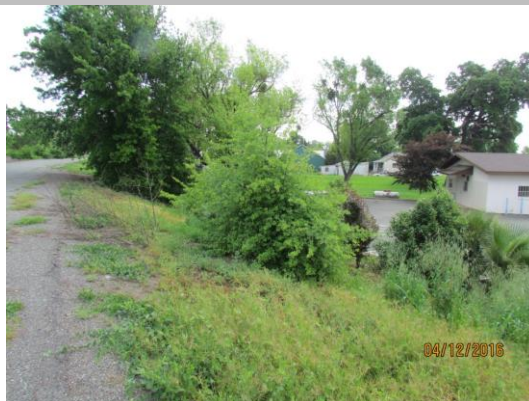
Photo 1 of 1 : SP_2017_NA0022_350_104_20170320_00084.jpg

View of the tree on the landward side of the levee looking downstream.
Spring 2016.

LM Start	0.42	Rating **	M	Issue No.	104
LM End	0.43	Issue Type +	En	Location *	LS
Category	Earthen Levee			GPS Latitude/Longitude	
				Start	End
Item	Vegetation			38.802106 °	38.802126 °
				-121.718269 °	-121.718133 °
DWR ID	DWR_NA0022_01_s _ 2016_104				
Comment Code					
V6 : Landscaping					
Inspector Comment					
Remove trees that are less than 4'.

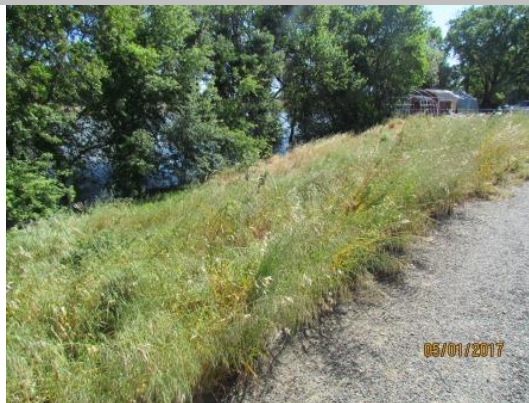
Photo 1 of 1 : SP_2017_NA0022_350_151_20170501_00165.jpg

View of tall grass on waterside levee slope, blocking visibility. Spring 2017.

LM Start	0.44	Rating **	U	Issue No.	151
LM End	0.51	Issue Type +	Ma	Location *	WS
Category	Earthen Levee			GPS Latitude/Longitude	
				Start	End
Item	Vegetation			38.802167 °	38.802033 °
				-121.717896 °	-121.716569 °
DWR ID	DWR_NA0022_01_s_2017_151				
Comment Code					
V1 : Control annual grass and weeds on the levee slopes and easements.					
Inspector Comment

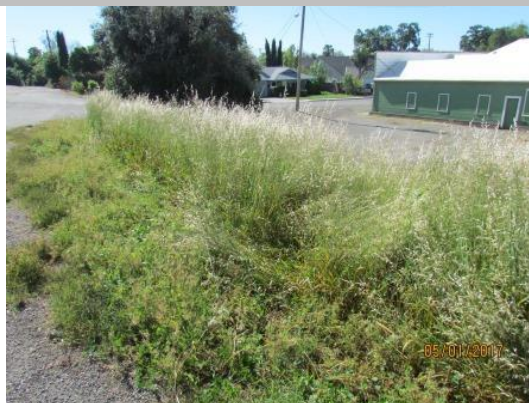
Photo 1 of 1 : SP_2017_NA0022_350_152_20170501_00166.jpg

View of tall grass on landside levee slope, blocking visibility. Spring 2017.

LM Start	0.44	Rating **	U	Issue No.	152
LM End	0.51	Issue Type +	Ma	Location *	LS
Category	Earthen Levee			GPS Latitude/Longitude	
				Start	End
Item	Vegetation			38.802167 °	38.802033 °
				-121.717896 °	-121.716569 °
DWR ID	DWR_NA0022_01_s_2017_152				
Comment Code					
V1 : Control annual grass and weeds on the levee slopes and easements.					
Inspector Comment

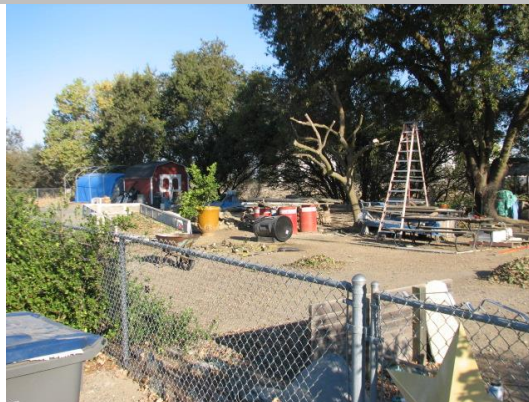
Photo 1 of 1 : SP_2017_NA0022_350_395_20170320_00098.jpg

LM Start	0.50	Rating **	M	Issue No.	395
LM End	0.54	Issue Type +	En	Location *	WS
Category	Earthen Levee			GPS Latitude/Longitude	
				Start	End
Item	Encroachments			38.802120 °	38.801882 °
				-121.716867 °	-121.716165 °
DWR ID	DWR_NA0022_01_f_2013_395				
Comment Code					
MA : Material					
Inspector Comment

Material blocking visibility on the waterside of the levee. Fall 2013

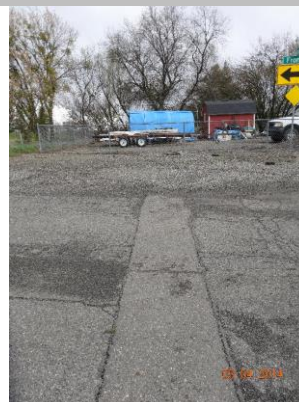
Photo 2 of 3 : UCIP_SP_2017_31627_57880.jpg

View of waterward side. Alignment is visible on paved road.

Comment Code					
Inspector Comment					
FS_ID:31627					
DS_ID:19544					
EP_NO: N/A					
Repair Type: Non-Urgent					
Crossing Status: Indicator Found					
UCIP Comments: Unable to confirm if signs of crossing are for the same crossing listed here. Need to contact owner and determine additional information about crossing. Also found is service box for water line--need permit and alignment confirmation.					
FIELD_STRUCT_DESC: 10-inch steel pipe through the levee at an unknown depth below the crown. [Additional Reference(s): DWR Levee Log, 1990 and 2005. USACE Sacramento O&M Manual Unit No. 127, June 1953, (Station 285+27)].					
FS Date: 3/4/2014

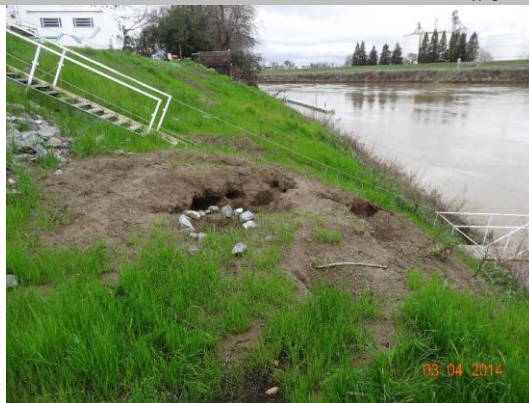
Photo 2 of 3 : UCIP_SP_2017_38188_69560.jpg

Item	DWR UCIP Field Study			38.801798 °	38.801798 °	
				-121.715584 °	-121.715584 °	
DWR ID						
Comment Code						
Inspector Comment						
FS_ID:38188 DS_ID:19519 EP_NO: N/A Repair Type: Non-Urgent Crossing Status: Indicator Found UCIP Comments: Unable to find any signs of crossing on waterward side. Signs of concrete riser visible on landward side. If crossing is abandoned owner will need to coordinate with the Central Valley Flood Protection Board (CVFPB) for Title 23 requirements. FIELD_STRUCT_DESC: 10-inch pipe of unknown material through the levee, 3.3 feet below the crown. Plate welded on waterside (WS) end in 1975. 24-inch concrete riser on the landside (LS). [Additional Reference(s): DWR Levee Log, 1990 and 2005]. FS Date: 3/4/2014

View of waterward slope. Large hole visible on waterward side.

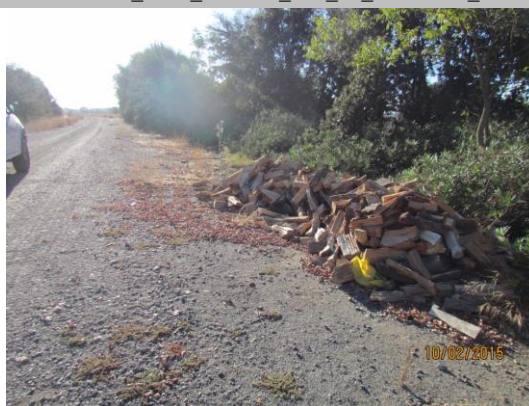
Photo 1 of 1 : SP_2017_NA0022_350_70_20170320_00053.jpg

LM Start	0.65	Rating **	A/W	Issue No.	70
LM End	0.65	Issue Type +	En	Location *	LS
Category	Earthen Levee			GPS Latitude/Longitude	
				Start	End
Item	Encroachments			38.801372 °	38.801372 °
				-121.714247 °	-121.714247 °
DWR ID	DWR_NA0022_01_f_2015_70				
Comment Code					
FW : Firewood					
Inspector Comment

View of the firewood on the landward side of the levee looking downstream. Fall 2015.

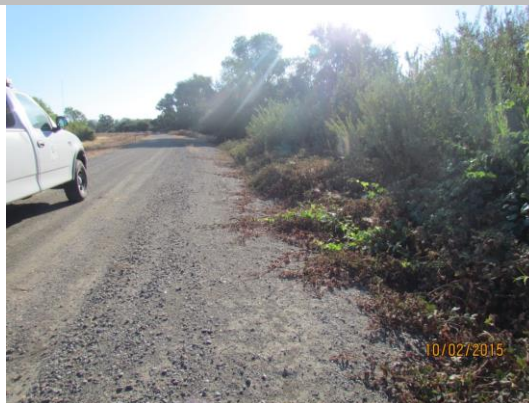
Photo 1 of 1 : SP_2017_NA0022_350_21_20170320_00020.jpg

View of the vegetation on the landward side of the levee looking downstream. Fall 2015.

LM Start	0.95	Rating **	U	Issue No.	21
LM End	1.32	Issue Type +	Ma	Location *	LS
Category	Earthen Levee			GPS Latitude/Longitude	
				Start	End
Item	Vegetation			38.800188 °	38.802017 °
				-121.708918 °	-121.702671 °
DWR ID	DWR_NA0022_01_s _ 2012_21				
Comment Code					
V2 : Remove the wild growth other than native grasses from the levee slopes.					
Inspector Comment					
Vegetation completely blocks visibility on the landward slope. Remove unwanted vegetation and trim and tin trees for visibility.

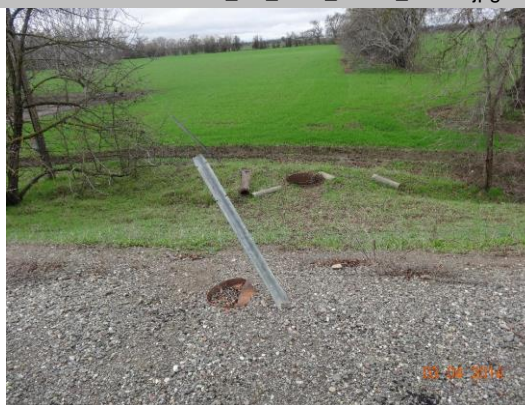
Photo 1 of 3 : UCIP_SP_2017_31912_58261.jpg

Comment Code					
Inspector Comment					
FS_ID:31912 DS_ID:19522 EP_NO: 6296 Repair Type: Non-Urgent Crossing Status: Found UCIP Comments: Siphon breaker housing on landward slope unit damaged and debris scattered on landward side. Unable to determine if crossing is still in use. Need to contact owner to determine status of crossing. FIELD_STRUCT_DESC: 12-inch (not 14 inch as indicated in desk study) irrigation pipe through the levee, 11.8 feet below the crown. 1.25 electrical conduit through the levee. Electrical control panel on waterside (WS) slope. Slant pump, mounted on steel structure on the WS bank. Siphon breaker on the landside (LS) shoulder. Standard corrugated metal cutoff wall around pipe at centerline of levee. Pipe extends from pump to existing irrigation ditch at LS toe. (Permit No. 6296, 1968 - Collier) [Additional Reference(s): DWR Levee Log, 1990 and 2005]. FS Date: 3/4/2014

View of landward side.

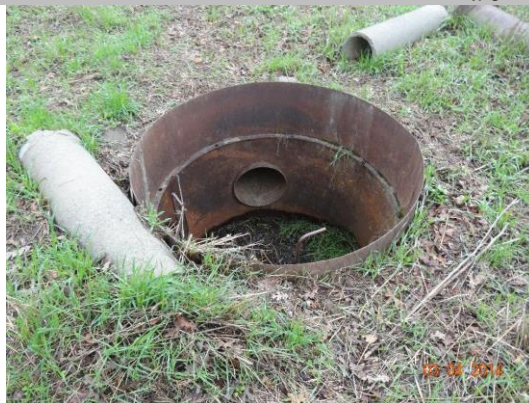
Photo 2 of 3 : UCIP_SP_2017_31912_58260.jpg

Riser on landward toe.

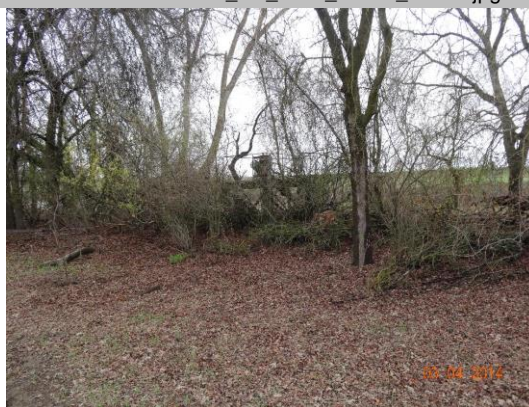
Photo 3 of 3 : UCIP_SP_2017_31912_58259.jpg

View of waterward side.

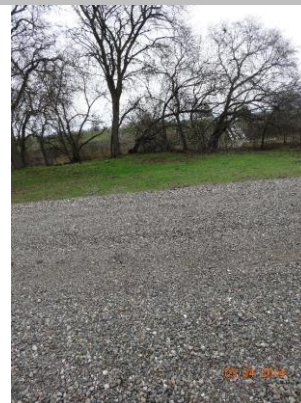
Photo 1 of 3 : UCIP_SP_2017_38190_69563.jpg

LM Start	1.75	Rating **	M	Issue No.	405
LM End	1.75	Issue Type +	En	Location *	WS
Category	Supplemental			GPS Latitude/Longitude	
				Start	End
Item	DWR UCIP Field Study			38.797928 °	38.797928 °
				-121.697992 °	-121.697992 °
DWR ID					
Comment Code					
Inspector Comment					
FS_ID:38190 DS_ID:19539 EP_NO: N/A Repair Type: Non-Urgent Crossing Status: Indicator Found UCIP Comments: Need to contact owner to determine status of crossing. FIELD_STRUCT_DESC: *ABANDONED* 12-inch (not 18-inch as mentioned in USACE O&M manual) corrugated metal irrigation pipe through the levee. Gate valve in pumphouse on waterside (WS) (no pump house found). Pipe was abandoned prior to 1968. [Additional Reference(s): USACE Sacramento O&M Manual Unit No. 127, June 1953, (Station 224+3.5)]. FS Date: 3/4/2014

View of waterward side.

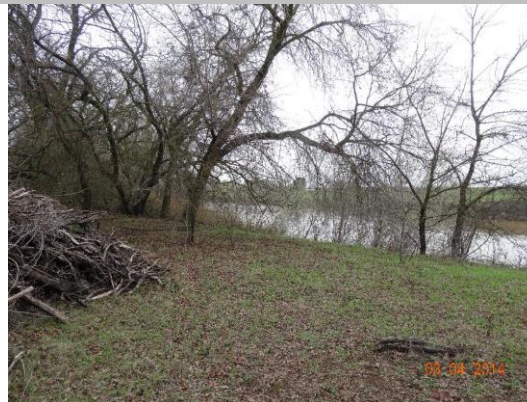
Photo 2 of 3 : UCIP_SP_2017_38190_69565.jpg

View of waterward side.

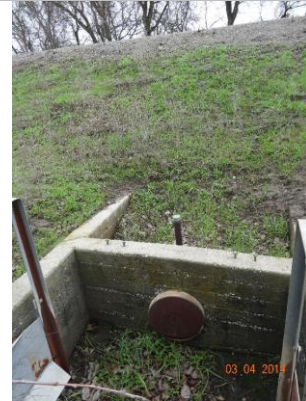
Photo 3 of 3 : UCIP_SP_2017_38190_69564.jpg

Concrete box located on landward toe.

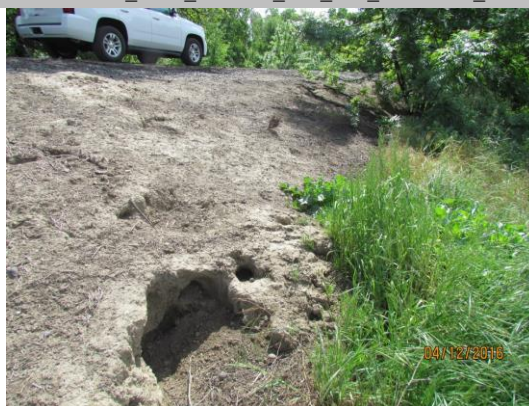
Photo 1 of 1 : SP_2017_NA0022_350_119_20170320_00091.jpg

View of the rodent hole on the landward side of the levee. Spring 2016.

LM Start	1.96	Rating **	M	Issue No.	119
LM End	1.96	Issue Type +	Ma	Location *	LS
Category	Earthen Levee			GPS Latitude/Longitude	
				Start	End
Item	Animal Control			38.795418 °	38.795418 °
				-121.695964 °	-121.695964 °
DWR ID	DWR_NA0022_01_s _ 2016_119				
Comment Code					
A3 : No rodents visible, but rodent burrows visible; need to backfill and compact or grout burrows.					
Inspector Comment

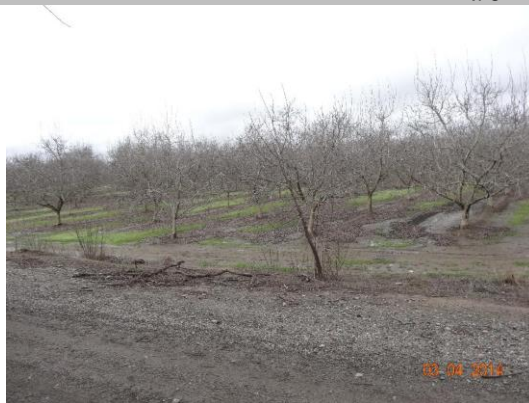
Photo 1 of 3 : UCIP_SP_2017_40536_58265.jpg

View of landward side.

Item	DWR UCIP Field Study			38.795248 °	38.795248 °	
				-121.695958 °	-121.695958 °	
DWR ID						
Comment Code						
Inspector Comment						
FS_ID:40536 DS_ID:19524 EP_NO: 9413 Repair Type: Non-Urgent Crossing Status: Found UCIP Comments: Alignment through levee unknown--no signs of crossing through landward side. Need to contact owner to determine status of crossing. This crossing appears to have been updated since 1970s. FIELD_STRUCT_DESC: 24-inch pipe through the levee, 15.5 feet below the crown. Gate valve on the landside (LS) end. Ramp on waterside (WS) slope. (Automatic Board Order (ABO) issued as Permit No. 9413, 1974 - Wallace Construction Company). Added appurtenances (noticed in 2014) pump, metal frame platform, flow meter, and control panel located on WS. Appurtenances could be associated with Permit No. 12804. [Additional Reference(s): DWR Levee Log, 1955, 1990, and 2005]. This appears to be the same entry as DS_ID 19538. FS Date: 3/4/2014

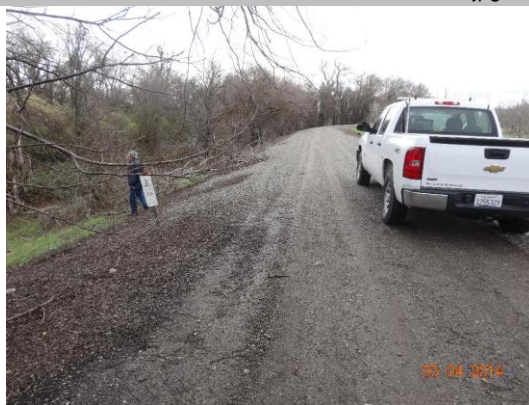
Photo 2 of 3 : UCIP_SP_2017_40536_58264.jpg

View of levee crown at crossing.

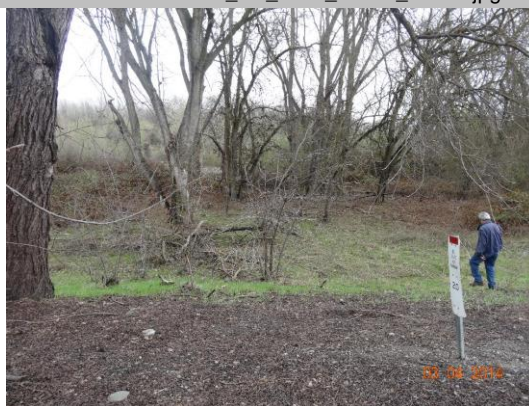
Photo 3 of 3 : UCIP_SP_2017_40536_58263.jpg

View of waterward side.

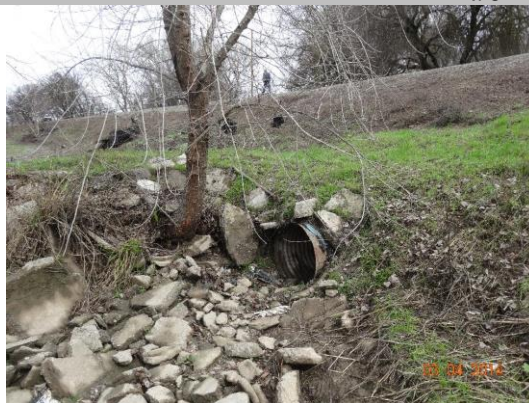
Photo 1 of 3 : UCIP_SP_2017_31632_57905.jpg

FS_ID:31632
DS_ID:19523
EP_NO: 9413
Repair Type: Non-Urgent
Crossing Status: Indicator Found
UCIP Comments: Erosion at outlet. Unable to determine if crossing is still in use. Will need to contact owner to determine status of crossing.
FIELD_STRUCT_DESC: 30-inch corrugated metal gravity pipe through the levee, 13.5 feet below the crown. Slide gate on both ends in 48-inch corrugated metal pipe (CMP) riser. (pipe retained under Automatic Board Order (ABO) issued as Permit No. 9413, 1974 - Wallace Construction Company; pump installed under Permit No. 12804, 1980 - Wallace Construction Company). Pumpstation appears to be located at CLM 1.969 and pipe runs along WS berm and discharges to ditch where the 30-inch pipe is used to convey the irrigation water to landside (LS) [Additional Reference(s): DWR Levee Log 1990 and 2005].
FS Date: 3/4/2014

Outlet located on landward toe.

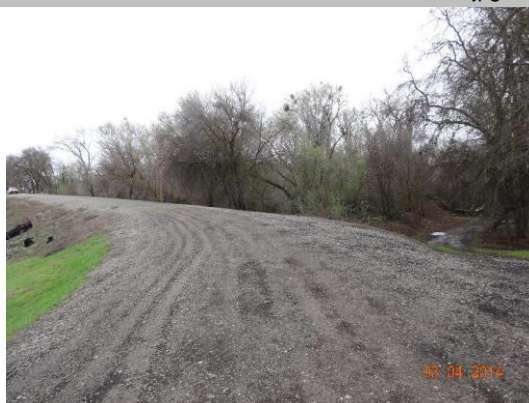
Photo 2 of 3 : UCIP_SP_2017_31632_57903.jpg

Overview of levee crown at crossing.

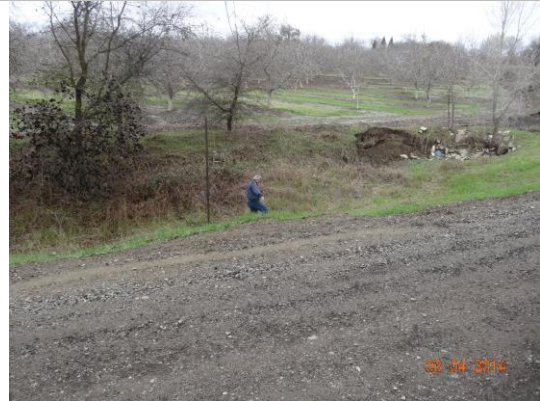
Photo 3 of 3 : UCIP_SP_2017_31915_58272.jpg

Comment Code					
Inspector Comment					
FS_ID:31915 DS_ID:19538 EP_NO: N/A Repair Type: Non-Urgent Crossing Status: Indicator Found UCIP Comments: Buried gate valve on landward slope. Crossing appears to be non-functional. Landward pipe section across canal has deteriorated. Will need to contact owner to determine status of crossing. If crossing is not in use owner will need to contact the CVFPB to abandon properly according to Title 23. FIELD_STRUCT_DESC: 20-inch corrugated metal drain pipe through the levee at an unknown depth. 20-inch gate valve is located on the landside (LS) slope. [Additional Reference(s): USACE Sacramento O&M Manual Unit No. 127, June 1953, (Station 208+15)]. This crossing could be the same record as DS_ID 19524--unable to confirm. FS Date: 3/4/2014

View of landward side.

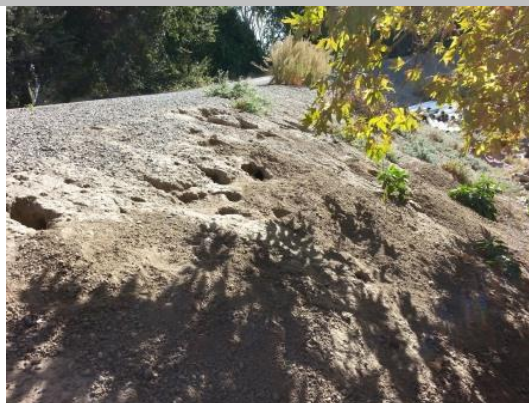
Photo 1 of 3 : SP_2017_NA0022_350_8_20170320_00009.jpg

LM Start	2.14	Rating **	U	Issue No.	8
LM End	2.27	Issue Type +	Ma	Location *	LS
Category	Earthen Levee			GPS Latitude/Longitude	
				Start	End
Item	Animal Control			38.792956 °	38.791249 °
				-121.696025 °	-121.695223 °
DWR ID	DWR_NA0022_01_s_2012_8				
Comment Code					
A3 : No rodents visible, but rodent burrows visible; need to backfill and compact or grout burrows.					
Inspector Comment					
More than 5 holes on 25-foot stretch.

View from levee toe on animal burrows on LS slope. Fall inspection 10/07/2016.

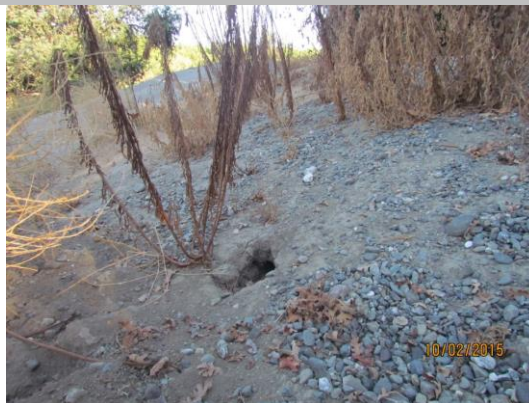
Photo 3 of 3 : SP_2017_NA0022_350_8_20170320_00011.jpg

LM Start	2.14	Rating **	U	Issue No.	8 (cont)	
LM End	2.27	Issue Type +	Ma	Location *	LS	
Category	Earthen Levee			GPS Latitude/Longitude		
				Start		End
Item	Animal Control			38.792956 °		38.791249 °
				-121.696025 °		-121.695223 °
DWR ID	DWR_NA0022_01_s_2012_8					
Comment Code						
A3 : No rodents visible, but rodent burrows visible; need to backfill and compact or grout burrows.						
Inspector Comment						
More than 5 holes on 25-foot stretch.

View of the rodent hole on the landward side of the levee looking downstream. Fall 2015.

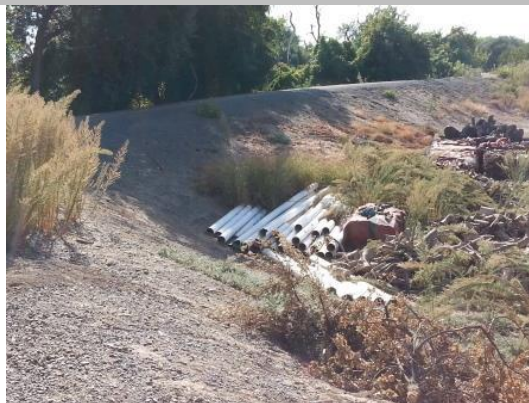
Photo 1 of 2 : SP_2017_NA0022_350_40_20170320_00038.jpg

LM Start	2.18	Rating **	M	Issue No.	40
LM End	2.18	Issue Type +	En	Location *	LS
Category	Earthen Levee			GPS Latitude/Longitude	
				Start	End
Item	Encroachments			38.792499 °	38.792499 °
				-121.695508 °	-121.695508 °
DWR ID	DWR_NA0022_01_s_2012_40				
Comment Code					
EQ : Equipment					
Inspector Comment					
Equipment is placed at the toe of the levee.

An updated view of the equipment on landward side. Fall inspection 10/07/2016.

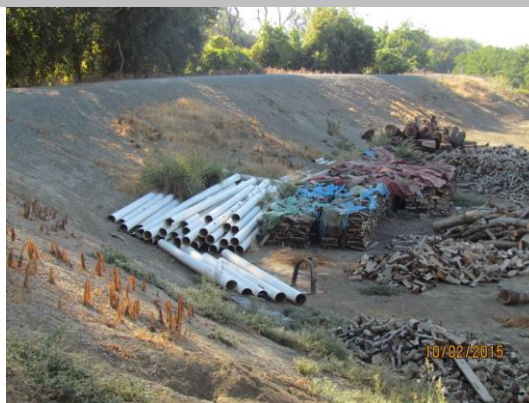
Photo 2 of 2 : SP_2017_NA0022_350_40_20170320_00039.jpg

View of equipment on the landward side of the levee looking downstream. Fall 2015.

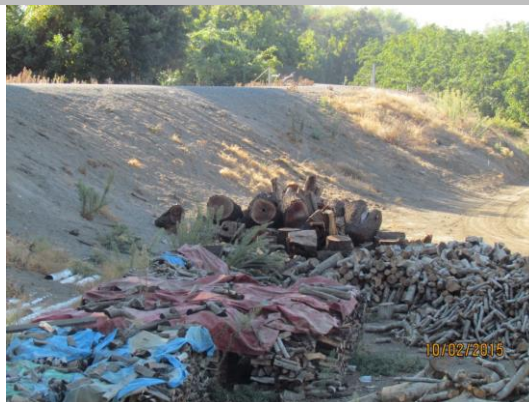
Photo 1 of 1 : SP_2017_NA0022_350_39_20170320_00037.jpg

LM Start	2.20	Rating **	M	Issue No.	39
LM End	2.20	Issue Type +	En	Location *	LS
Category	Earthen Levee			GPS Latitude/Longitude	
				Start	End
Item	Encroachments			38.792283 °	38.792283 °
				-121.695447 °	-121.695447 °
DWR ID	DWR_NA0022_01_s_2012_39				
Comment Code					
FW : Firewood					
Inspector Comment					
Firewood is placed at the levee toe.

View of the growing firewood at the toe of the landward side of the levee looking downstream. Fall 2015.

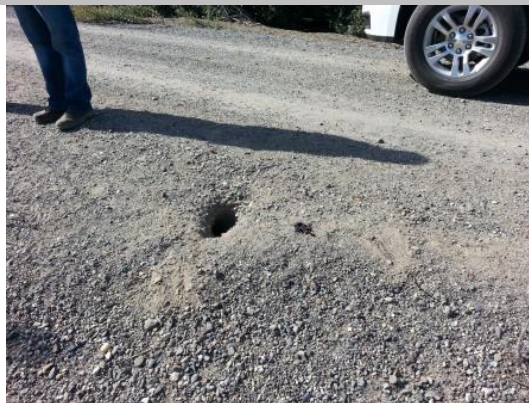
Photo 1 of 1 : SP_2017_NA0022_350_86_20170320_00068.jpg

LM Start	2.26	Rating **	M	Issue No.	86
LM End	2.26	Issue Type +	Ma	Location *	CR
Category	Earthen Levee			GPS Latitude/Longitude	
				Start	End
Item	Animal Control			38.791391 °	38.791391 °
				-121.695305 °	-121.695305 °
DWR ID	DWR_NA0022_01_f_2016_86				
Comment Code					
A3 : No rodents visible, but rodent burrows visible; need to backfill and compact or grout burrows.					
Inspector Comment

Rodent hole on levee crown. Fall inspection 10/07/2016.

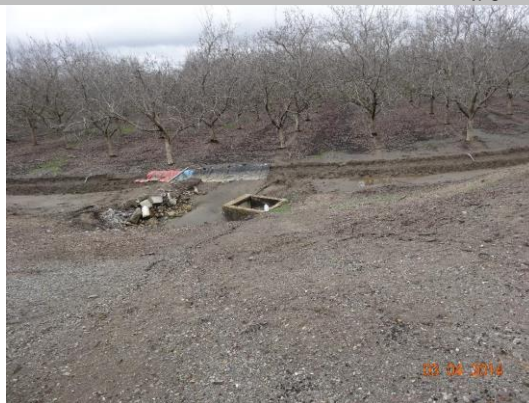
Photo 1 of 3 : UCIP_SP_2017_49982_57915.jpg

Comment Code					
Inspector Comment					
FS_ID:49982 DS_ID:19525 EP_NO: N/A Repair Type: Urgent Crossing Status: Indicator Found UCIP Comments: 7/13/2016 same as last inspection. Erosion has progressed--Need to coordinate with owner to address erosion on LS toe. (DWR UCIP - omagana)3/04/2014 Surface erosion near concrete box on landward side. Unable to determine if crossing is leaking or if pump is pulling sand from waterward side. Need to contact owner to determine status of crossing and to check integrity of crossing. (DWR UCIP - omagana) FIELD_STRUCT_DESC: 16-inch steel irrigation pipe through the levee, 4 feet below the crown (levee logs from 1955 indicate crossing is 18.9 feet below crown). Concrete well and pumphouse located on the waterside (WS). Screw gate is located in pump house. Slant pump mounted on steel structure on the WS bank, installed under Permit No. 5951 (1967). Concrete discharge box (4-feet by 4-feet) is located on the toe of landside (LS) slope. Overhead powerline and anchor crosses levee. Pole is located on both shoulders. [Additional Reference(s): DWR Levee Log, 1955, 1990, and 2005. USACE Sacramento O&M Manual Unit No. 127, June 1953, (Station 192+60)]. FS Date: 7/13/2016

View of LS toe.

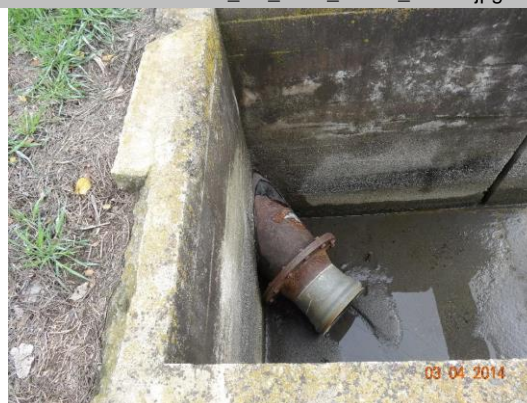
Photo 3 of 3 : UCIP_SP_2017_49982_57913.jpg

Item	DWR UCIP Field Study			38.790260 °		38.790260 °
				-121.694510 °		-121.694510 °
DWR ID						
Comment Code						
Inspector Comment						
FS_ID:49982 DS_ID:19525 EP_NO: N/A Repair Type: Urgent Crossing Status: Indicator Found UCIP Comments: 7/13/2016 same as last inspection. Erosion has progressed--Need to coordinate with owner to address erosion on LS toe. (DWR UCIP - omagana)3/04/2014 Surface erosion near concrete box on landward side. Unable to determine if crossing is leaking or if pump is pulling sand from waterward side. Need to contact owner to determine status of crossing and to check integrity of crossing. (DWR UCIP - omagana) FIELD_STRUCT_DESC: 16-inch steel irrigation pipe through the levee, 4 feet below the crown (levee logs from 1955 indicate crossing is 18.9 feet below crown). Concrete well and pumphouse located on the waterside (WS). Screw gate is located in pump house. Slant pump mounted on steel structure on the WS bank, installed under Permit No. 5951 (1967). Concrete discharge box (4-feet by 4-feet) is located on the toe of landside (LS) slope. Overhead powerline and anchor crosses levee. Pole is located on both shoulders. [Additional Reference(s): DWR Levee Log, 1955, 1990, and 2005. USACE Sacramento O&M Manual Unit No. 127, June 1953, (Station 192+60)]. FS Date: 7/13/2016

Outlet located on LS.

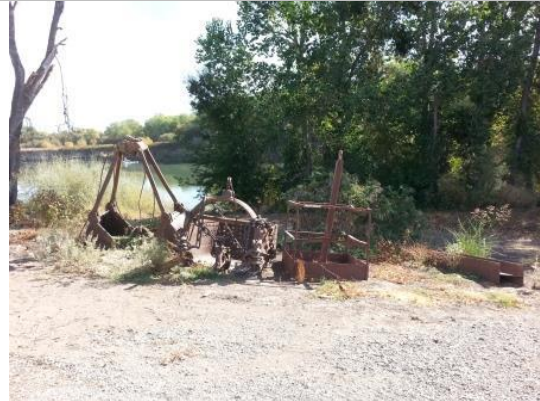
Photo 1 of 1 : SP_2017_NA0022_350_97_20170320_00080.jpg

LM Start	2.35	Rating **	M	Issue No.	97
LM End	2.35	Issue Type +	En	Location *	WS
Category	Earthen Levee			GPS Latitude/Longitude	
				Start	End
Item	Encroachments			38.790175 °	38.790175 °
				-121.694519 °	-121.694519 °
DWR ID	DWR_NA0022_01_f_2016_97				
Comment Code					
EQ : Equipment					
Inspector Comment

Equipment on waterside slope. Fall inspection 10/07/2016.

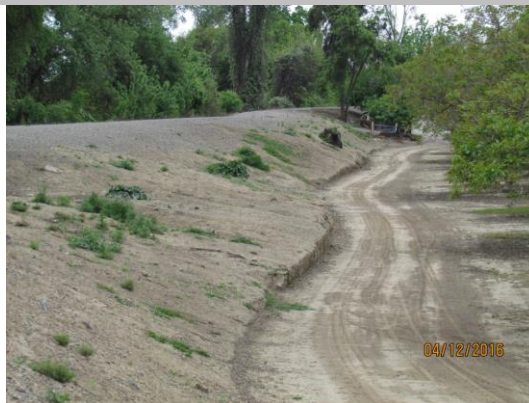
Photo 2 of 2 : SP_2017_NA0022_350_94_20170320_00076.jpg

LM Start	2.41	Rating **	M	Issue No.	94 (cont)	
LM End	2.55	Issue Type +	En	Location *	LS	
Category	Earthen Levee			GPS Latitude/Longitude		
				Start		End
Item	Encroachments			38.789382 °		38.787405 °
				-121.694584 °		-121.694283 °
DWR ID	DWR_NA0022_01_s_2016_94					
Comment Code						
AT : Agricultural tilling						
Inspector Comment						
Cut at the toe of the levee.

View of the cut at the levee toe on the landward side looking downstream. Spring 2016.

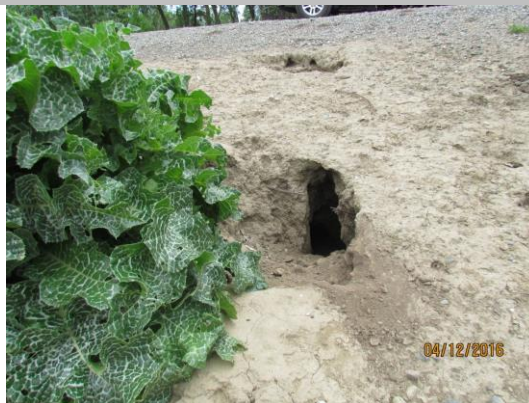
Photo 1 of 2 : SP_2017_NA0022_350_123_20170320_00093.jpg

LM Start	2.52	Rating **	U	Issue No.	123
LM End	2.52	Issue Type +	Ma	Location *	LS
Category	Earthen Levee			GPS Latitude/Longitude	
				Start	End
Item	Animal Control			38.787768 °	38.787768 °
				-121.694295 °	-121.694295 °
DWR ID	DWR_NA0022_01_s_2016_123				
Comment Code					
A3 : No rodents visible, but rodent burrows visible; need to backfill and compact or grout burrows.					
Inspector Comment

View of the rodent hole next to a tree stump on the landward side of the levee. Spring 2016.

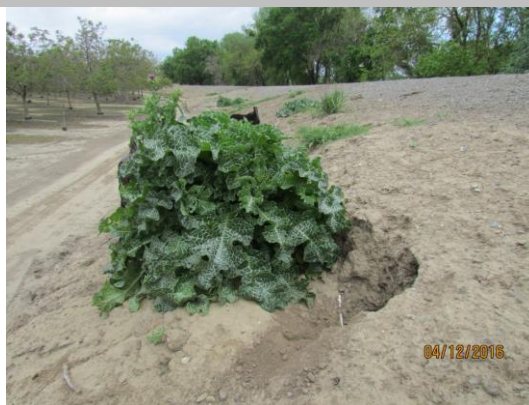
Photo 2 of 2 : SP_2017_NA0022_350_123_20170320_00094.jpg

Perspective view of the rodent hole looking upstream. Spring 2016.

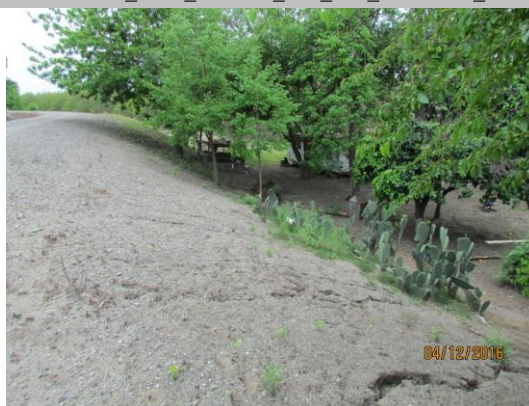
Photo 1 of 1 : SP_2017_NA0022_350_124_20170320_00095.jpg

LM Start	2.59	Rating **	M	Issue No.	124
LM End	2.59	Issue Type +	En	Location *	LS
Category	Earthen Levee			GPS Latitude/Longitude	
				Start	End
Item	Vegetation			38.786780 °	38.786780 °
				-121.694317 °	-121.694317 °
DWR ID	DWR_NA0022_01_s_2016_124				
Comment Code					
V6 : Landscaping					
Inspector Comment

View of the cactuses and trees at the toe of the levee on the landward side looking downstream. Spring 2016.

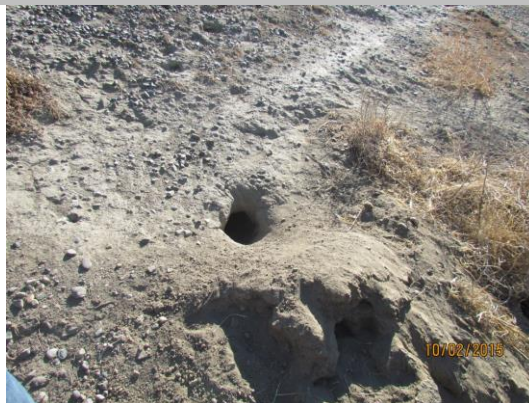
Photo 2 of 2 : SP_2017_NA0022_350_52_20170320_00048.jpg

LM Start	2.87	Rating **	U	Issue No.	52 (cont)	
LM End	2.92	Issue Type +	Ma	Location *	LS	
Category	Earthen Levee			GPS Latitude/Longitude		
				Start		End
Item	Animal Control			38.783571 °	38.783021 °	
				-121.692110 °	-121.691633 °	
DWR ID	DWR_NA0022_01_f_2013_52					
Comment Code						
A1 : Exterminate rodents and backfill and compact or grout burrows.						
Inspector Comment

There are multiple rodent holes in this area. Fall 2015.

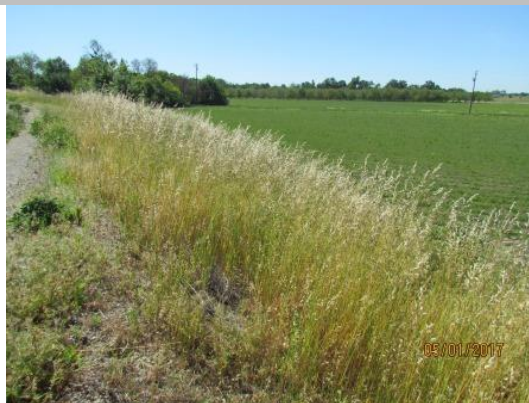
Photo 1 of 1 : SP_2017_NA0022_350_166_20170501_00168.jpg

LM Start	2.94	Rating **	U	Issue No.	166
LM End	3.07	Issue Type +	Ma	Location *	LS
Category	Earthen Levee			GPS Latitude/Longitude	
				Start	End
Item	Vegetation			38.782835 °	38.781785 °
				-121.691328 °	-121.689402 °
DWR ID	DWR_NA0022_01_s _ 2017_166				
Comment Code					
V1 : Control annual grass and weeds on the levee slopes and easements.					
Inspector Comment

View of tall grass on landside levee slope, blocking visibility. Spring 2017.

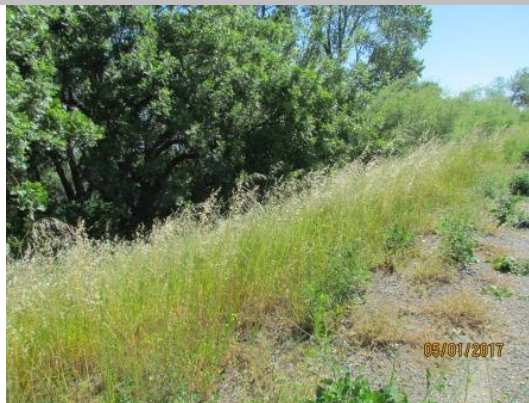
Photo 1 of 1 : SP_2017_NA0022_350_168_20170501_00169.jpg

LM Start	3.00	Rating **	U	Issue No.	168
LM End	3.07	Issue Type +	Ma	Location *	WS
Category	Earthen Levee			GPS Latitude/Longitude	
				Start	End
Item	Vegetation			38.782366 °	38.781783 °
				-121.690369 °	-121.689403 °
DWR ID	DWR_NA0022_01_s_2017_168				
Comment Code					
V1 : Control annual grass and weeds on the levee slopes and easements.					
Inspector Comment

View of tall grass on waterside levee slope, blocking visibility. Spring 2017.

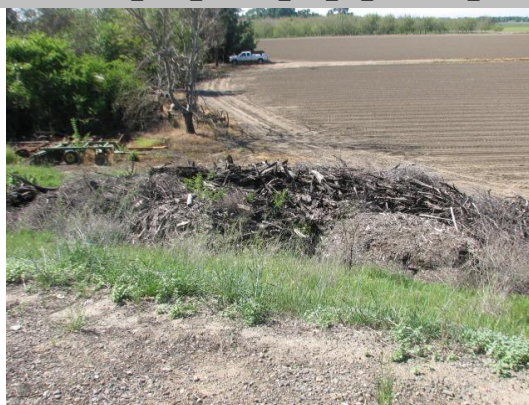
Photo 1 of 1 : SP_2017_NA0022_350_42_20170320_00040.jpg

LM Start	3.02	Rating **	M	Issue No.	42
LM End	3.02	Issue Type +	En	Location *	LS
Category	Earthen Levee			GPS Latitude/Longitude	
				Start	End
Item	Encroachments			38.782239 °	38.782239 °
				-121.690037 °	-121.690037 °
DWR ID	DWR_NA0022_01_s_2014_42				
Comment Code					
PR : Prunings					
Inspector Comment

A large pruning pile near the toe of the levee. Spring 2014

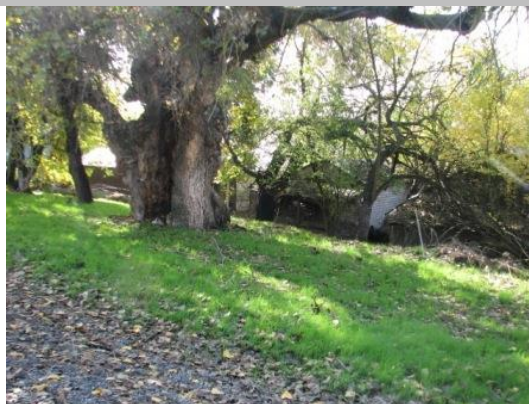
Photo 1 of 2 : SP_2017_NA0022_350_12_20170320_00014.jpg

LM Start	3.06	Rating **	M	Issue No.	12
LM End	3.14	Issue Type +	En	Location *	LS
Category	Earthen Levee			GPS Latitude/Longitude	
				Start	End
Item	Encroachments			38.781828 °	38.780852 °
				-121.689415 °	-121.688887 °
DWR ID	DWR_NA0022_01_s_2012_12				
Comment Code					
BU : Building					
Inspector Comment

Buildings are located at the toe of the levee. Fall 2012

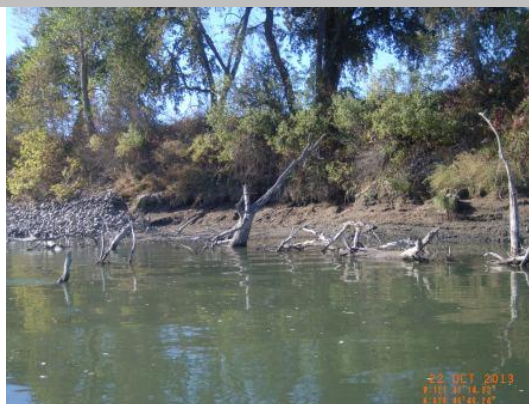
Photo 1 of 1 : SP_2017_NA0022_350_5_20170320_00006.jpg

LM Start	3.18	Rating **	M	Issue No.	5
LM End	3.28	Issue Type +	Ma	Location *	WS
Category	Supplemental			GPS Latitude/Longitude	
				Start	End
Item	2015 USACE Erosion Survey, DRAFT			38.780407 °	38.779137 °
				-121.688238 °	-121.687432 °
DWR ID	DWR_NA0022_01_s_2016_5				
Comment Code					
Inspector Comment					
2006 - Short section is into the levee toe, rest is near the levee toe. Mass failure and fluvial erosion of depositional material. Rock at the upstream and downstream ends. 2011 - Minor new erosion. 2012 - Slope continues to steepen, tree roots have become exposed, and new eddy formed. 2015: No observed changes. [2015 Site ID: SAC 86-9 R]

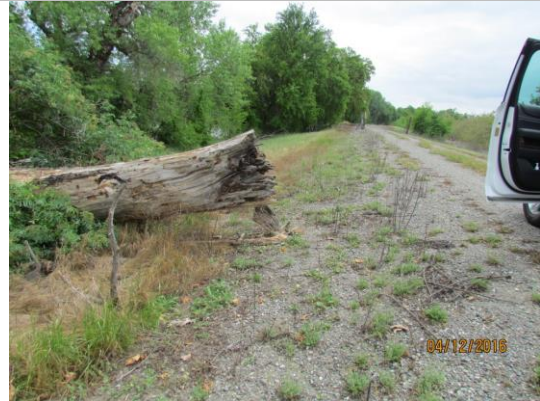
Photo 1 of 1 : SP_2017_NA0022_350_15_20170320_00017.jpg

LM Start	3.20	Rating **	M	Issue No.	15
LM End	3.20	Issue Type +	Ma	Location *	WS
Category	Earthen Levee			GPS Latitude/Longitude	
				Start	End
Item	Encroachments			38.780032 °	38.780032 °
				-121.688508 °	-121.688508 °
DWR ID	DWR_NA0022_01_s_2016_15				
Comment Code					
TR : Tree or limb					
Inspector Comment

View of the fallen tree on the waterward slope of the levee looking downstream. Spring 2016.

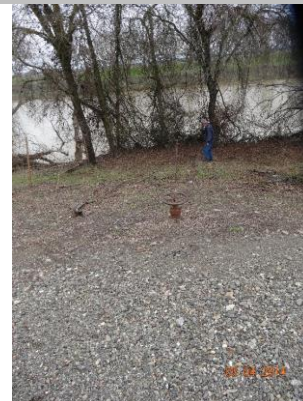
Photo 1 of 3 : UCIP_SP_2017_39858_71841.jpg

Comment Code					
Inspector Comment					
FS_ID:39858 DS_ID:19526 EP_NO: 3205 Repair Type: Non-Urgent Crossing Status: Found UCIP Comments: Need to contact owner to determine status of crossing. If crossing is no longer used need to coordinate with CVFPB for proper abandonment. FIELD_STRUCT_DESC: 12-inch irrigation pipe of unknown material through the levee, 4 feet below the crown. Pump is located on the waterside (WS). Gate valve is located on the WS slope. Siphon breaker is located inside an 18-inch concrete riser located on the landside (LS) slope. 36-inch concrete standpipe is located at toe of LS slope. Metal cutoff wall installed. Permit No. 3205 was issued in 1959 for the removal of an existing 12-inch pipe (USACE O&M Station 144+80) and re-installment of a 12-inch pipe. (Permit No. 3205, 1959 - Richardson) [Additional Reference(s): DWR Levee Log, 1955, 1990, and 2005. USACE Sacramento O&M Manual Unit No. 127, June 1953, (Station 144+80)]. FS Date: 3/4/2014

View of waterward side.

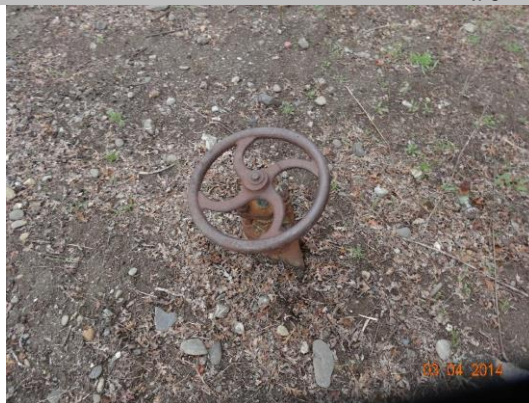
Photo 2 of 3 : UCIP_SP_2017_39858_71840.jpg

Item	DWR UCIP Field Study			38.779625 °	38.779625 °	
				-121.688090 °	-121.688090 °	
DWR ID						
Comment Code						
Inspector Comment						
FS_ID:39858 DS_ID:19526 EP_NO: 3205 Repair Type: Non-Urgent Crossing Status: Found UCIP Comments: Need to contact owner to determine status of crossing. If crossing is no longer used need to coordinate with CVFPB for proper abandonment. FIELD_STRUCT_DESC: 12-inch irrigation pipe of unknown material through the levee, 4 feet below the crown. Pump is located on the waterside (WS). Gate valve is located on the WS slope. Siphon breaker is located inside an 18-inch concrete riser located on the landside (LS) slope. 36-inch concrete standpipe is located at toe of LS slope. Metal cutoff wall installed. Permit No. 3205 was issued in 1959 for the removal of an existing 12-inch pipe (USACE O&M Station Station 144+80) and re-installment of a 12-inch pipe. (Permit No. 3205, 1959 - Richardson) [Additional Reference(s): DWR Levee Log, 1955, 1990, and 2005. USACE Sacramento O&M Manual Unit No. 127, June 1953, (Station 144+80)]. FS Date: 3/4/2014

Positive closure device is buried on waterward side.

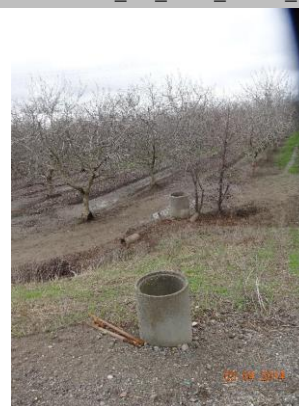
Photo 1 of 3 : UCIP_SP_2017_31916_58275.jpg

Comment Code					
Inspector Comment					
FS_ID:31916 DS_ID:19545 EP_NO: N/A Repair Type: Non-Urgent Crossing Status: Indicator Found UCIP Comments: Need to contact owner--Crossing appears to be abandoned. If crossing is no longer in use, crossing need to be abandoned properly per Title 23. FIELD_STRUCT_DESC: *REMOVED* 12-inch steel irrigation pipe through the levee. Pump is located on the waterside (WS). Concrete standpipe is located on the landside (LS). Permit No. 3205 was issued in 1959 for the removal of an existing 12-inch pipe (USACE O&M Station Station 144+80) and re-installment of a new 12-inch pipe. [Additional Reference(s): USACE Sacramento O&M Manuals: Unit No. 127, June 1953, (Station 144+80)]. FS Date: 3/4/2014

View of landward side.

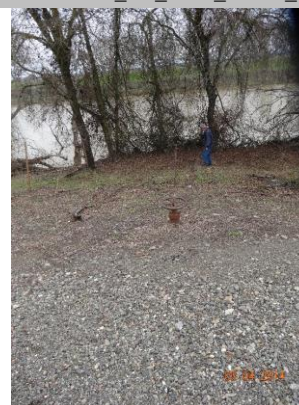
Photo 2 of 3 : UCIP_SP_2017_31916_58274.jpg

View of waterward side.

Item	DWR UCIP Field Study			38.779543 °	38.779543 °	
				-121.688170 °	-121.688170 °	
DWR ID						
Comment Code						
Inspector Comment						
FS_ID:31916 DS_ID:19545 EP_NO: N/A Repair Type: Non-Urgent Crossing Status: Indicator Found UCIP Comments: Need to contact owner--Crossing appears to be abandoned. If crossing is no longer in use, crossing need to be abandoned properly per Title 23. FIELD_STRUCT_DESC: *REMOVED* 12-inch steel irrigation pipe through the levee. Pump is located on the waterside (WS). Concrete standpipe is located on the landside (LS). Permit No. 3205 was issued in 1959 for the removal of an existing 12-inch pipe (USACE O&M Station Station 144+80) and re-installment of a new 12-inch pipe. [Additional Reference(s): USACE Sacramento O&M Manuals: Unit No. 127, June 1953, (Station 144+80)]. FS Date: 3/4/2014

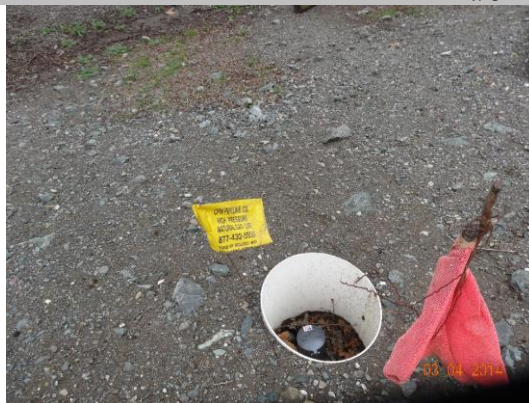
Photo 3 of 3 : UCIP_SP_2017_31917_58281.jpg

Item	DWR UCIP Field Study			38.777190 °		38.777190 °
				-121.687048 °		-121.687048 °
DWR ID						
Comment Code						
Inspector Comment						
FS_ID:31917 DS_ID:19527 EP_NO: 3729 Repair Type: Non-Urgent Crossing Status: Found UCIP Comments: Crossing has been modified. Need to contact owner to determine additional information pertaining to the modifications. FIELD_STRUCT_DESC: 10-inch irrigation pipe through the levee, 3 feet below the crown. 1.5-inch conduit through the levee. 1-foot below the crown. Service pole and meter at toe of landward slope. Gate valve and pump on the waterward bank. Access ramp to pump location. Siphon breaker on the landward shoulder, in 12-inch concrete riser. Metal cutoff wall installed. (Permit No. 3729-1961).[Additional Reference(s): DWR Levee Log, 1990 and 2005]. FS Date: 3/4/2014

Flow meter located on waterward shoulder.

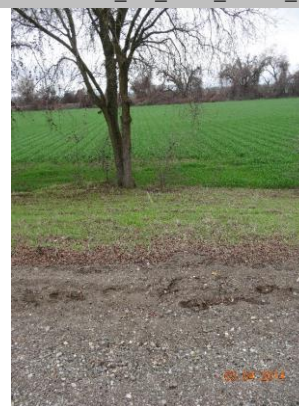
Photo 1 of 3 : UCIP_SP_2017_38996_69568.jpg

Comment Code					
Inspector Comment					
FS_ID:38996 DS_ID:19528 EP_NO: 3722 Repair Type: Non-Urgent Crossing Status: Found UCIP Comments: Pipe visible only on waterward side--Pipe needs to be properly abandoned per Title 23. Need to contact owner to determine status of crossing. FIELD_STRUCT_DESC: *ABANDONED* 10-inch steel pipe through the levee, 3 feet below the crown. 1.5-inch conduit 1 foot below the crown. Pump and gate valve on the waterside (WS) bank. Metal cutoff walls at centerline of levee. Siphon breaker is located on the landside (LS) shoulder in a 12-inch concrete riser. Pipe connects to existing 24-inch concrete standpipe at LS toe. (Permit No. 3722, 1961 - Traganza). No standpipe found on LS toe. In the 1955 DWR Levee Log the crossing was referenced as a 10-inch pipe at 5.3 feet below the crown at HLM 3.60. [Additional Reference(s): DWR Levee Log, 1955, 1990, and 2005]. FS Date: 3/4/2014

View of landward side.

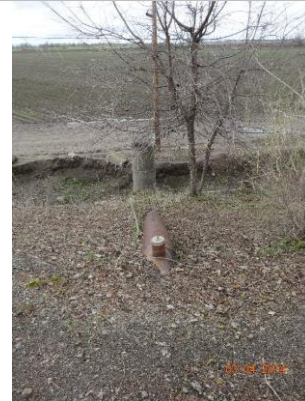
Photo 1 of 3 : UCIP_SP_2017_38999_57948.jpg

Comment Code					
Inspector Comment					
FS_ID:38999 DS_ID:19529 EP_NO: 4570 Repair Type: Non-Urgent Crossing Status: Found UCIP Comments: Need to contact owner to determine status of crossing. CMP riser damage on waterward slope. FIELD_STRUCT_DESC: 16-inch pipe through the levee, 5.0 feet below the crown. Metal plate welded on the waterside (WS) end. Pump, 1.5-inch conduit, and gate valve in concrete U-headwall are located on the WS bank, installed under Permit 7618A (1971). Pipe extends from pump to concrete standpipe on the landside (LS), pipe exposed on the LS slope. Water meter in 36-inch corrugated metal pipe (CMP) riser located on the WS slope. Siphon breaker on the LS shoulder, in 7-inch metal riser. 30-inch concrete riser at toe of LS slope. Metal cutoff wall installed. (Permit No. 4570, 1964 - England Brothers). [Additional Reference(s): DWR Levee Log, 1990 and 2005]. FS Date: 3/4/2014

View of landward side.

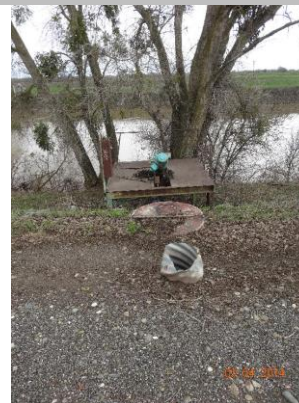
Photo 2 of 3 : UCIP_SP_2017_38999_57947.jpg

Item	DWR UCIP Field Study			38.770295 °	38.770295 °	
				-121.692580 °	-121.692580 °	
DWR ID						
Comment Code						
Inspector Comment						
FS_ID:38999 DS_ID:19529 EP_NO: 4570 Repair Type: Non-Urgent Crossing Status: Found UCIP Comments: Need to contact owner to determine status of crossing. CMP riser damage on waterward slope. FIELD_STRUCT_DESC: 16-inch pipe through the levee, 5.0 feet below the crown. Metal plate welded on the waterside (WS) end. Pump, 1.5-inch conduit, and gate valve in concrete U-headwall are located on the WS bank, installed under Permit 7618A (1971). Pipe extends from pump to concrete standpipe on the landside (LS), pipe exposed on the LS slope. Water meter in 36-inch corrugated metal pipe (CMP) riser located on the WS slope. Siphon breaker on the LS shoulder, in 7-inch metal riser. 30-inch concrete riser at toe of LS slope. Metal cutoff wall installed. (Permit No. 4570, 1964 - England Brothers). [Additional Reference(s): DWR Levee Log, 1990 and 2005]. FS Date: 3/4/2014

View of waterward side.

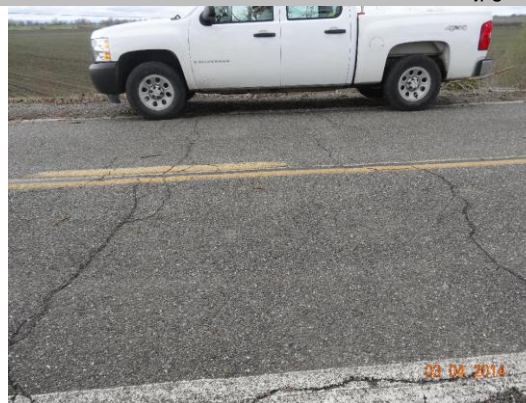
Photo 3 of 3 : UCIP_SP_2017_38999_57946.jpg

View of levee crown at crossing.

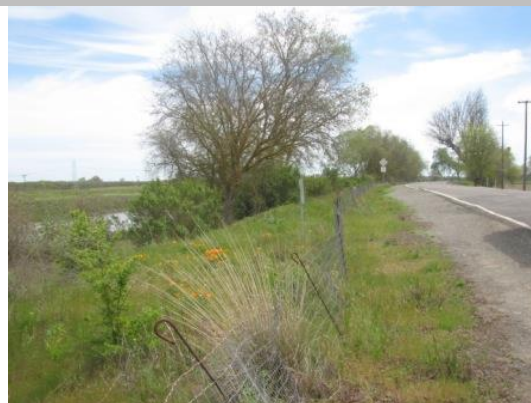
Photo 1 of 2 : SP_2017_NA0022_350_36_20170320_00034.jpg

LM Start	4.25	Rating **	A/W	Issue No.	36
LM End	4.49	Issue Type +	Ma	Location *	WS
Category	Earthen Levee			GPS Latitude/Longitude	
				Start	End
Item	Vegetation			38.767125 °	38.764582 °
				-121.693267 °	-121.690285 °
DWR ID	DWR_NA0022_01_s_2012_36				
Comment Code					
V8 : Environmental Requirements.					
Inspector Comment

Another view of the site.

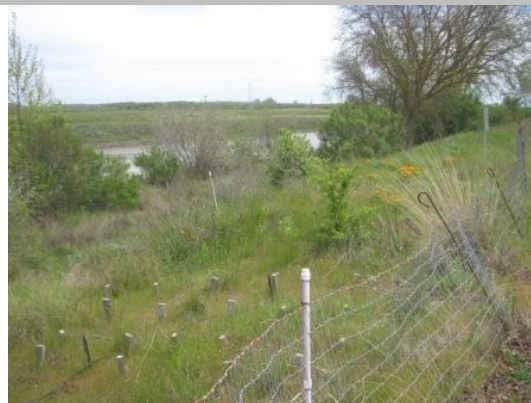
Photo 2 of 2 : SP_2017_NA0022_350_36_20170320_00035.jpg

Fence, irrigation and stakes in the revegetation site.

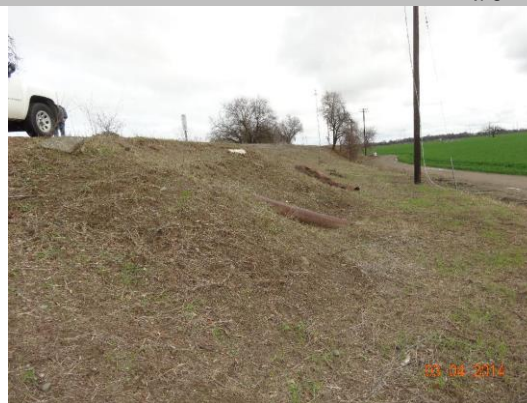
Photo 1 of 3 : UCIP_SP_2017_31986_58442.jpg

LM Start	4.44	Rating **	M	Issue No.	415
LM End	4.44	Issue Type +	En	Location *	LS
Category	Supplemental			GPS Latitude/Longitude	
				Start	End
Item	DWR UCIP Field Study			38.765142 °	38.765142 °
				-121.690963 °	-121.690963 °
DWR ID					
Comment Code					
Inspector Comment					
FS_ID:31986 DS_ID:19530 EP_NO: 9409 Repair Type: Non-Urgent Crossing Status: Found UCIP Comments: Pump station not found. Crossing appears to be abandon. Need to contact owner to determine status. Repair site on waterward side--waterward slope revegetated. FIELD_STRUCT_DESC: 16-inch steel pipe through the levee, 6.4 feet below the crown. Pump and control valve are located on the waterside (WS) bank. Ramp is located on landside (LS) slope. (Automatic Board Order (ABO) issued as Permit No. 9409, 1974 - Russell). [Additional Reference(s): DWR Levee Log, 1990 and 2005]. FS Date: 3/4/2014

View of landward side.

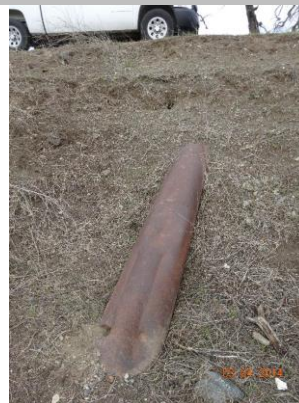
Photo 2 of 3 : UCIP_SP_2017_31986_58439.jpg

Item	DWR UCIP Field Study			38.765142 °	38.765142 °	
				-121.690963 °	-121.690963 °	
DWR ID						
Comment Code						
Inspector Comment						
FS_ID:31986						
DS_ID:19530						
EP_NO: 9409						
Repair Type: Non-Urgent						
Crossing Status: Found						
UCIP Comments: Pump station not found. Crossing appears to be abandon. Need to contact owner to determine status. Repair site on waterward side--waterward slope revegetated.						
FIELD_STRUCT_DESC: 16-inch steel pipe through the levee, 6.4 feet below the crown. Pump and control valve are located on the waterside (WS) bank. Ramp is located on landside (LS) slope. (Automatic Board Order (ABO) issued as Permit No. 9409, 1974 - Russell). [Additional Reference(s): DWR Levee Log, 1990 and 2005].						
FS Date: 3/4/2014

Pipe through levee punctured visible on landward slope.
